SPRING LAKE ESTATES HOME OWNERS ASSOCIATION

2019 INSPECTION REPORT Permit No. 17607 Dam ID No. IL 00545

SPRING LAKE DAM WINNEBAGO, COUNTY, ILLINOIS

Observed by: Arc Design Resources, Inc. 5291 Zenith Parkway Loves Park, IL 61111

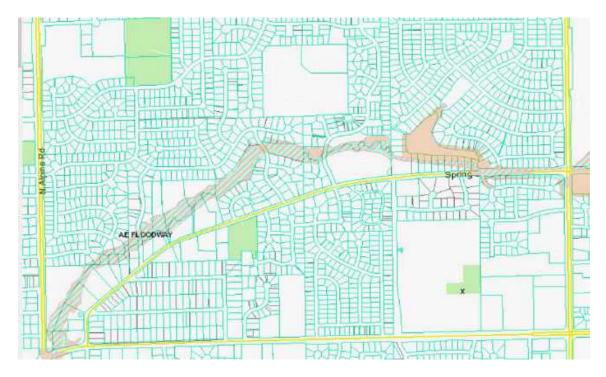
The partial map from WinGIS shows the dam location and the downstream conditions which extend approximately 1 mile down stream to Alpine Road and Spring Creek. Residential development is located downstream but is situated outside of the floodway and floodplain. Data taken from 2016 FEMA information.
