## **2020 INTERIM INSPECTION MEMO Permit No. 17607 Dam ID No. IL 00545**

**SPRING LAKE DAM  
WINNEBAGO, COUNTY, ILLINOIS**

October 21, 2020

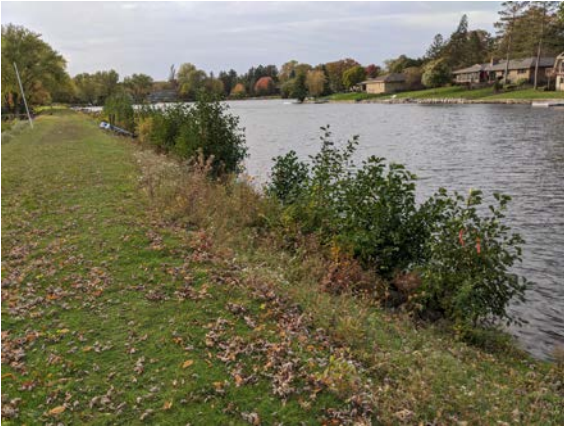
Woody plant material along bank must be removed.

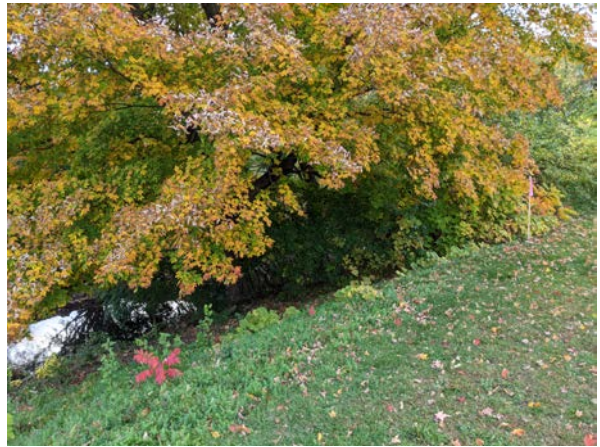
Tree trimming required for sunlight to reach embankment for grass growth, woody bush removal required.

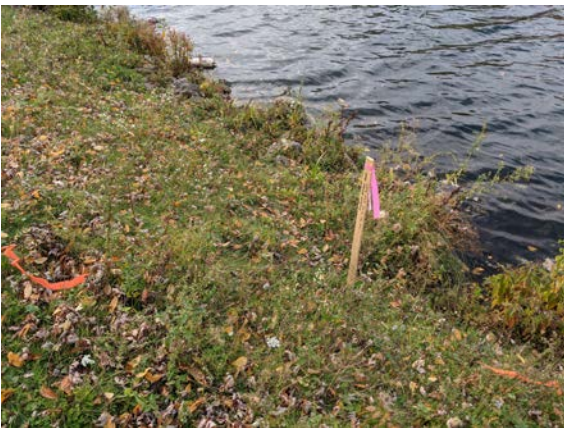
Sloughing and holes must be filled as specified with surface restoration.

Hole 4	3	3-4" diameter hole in surface of dam face, back slope		Remove vegetation, fill with compacted clay, cap with 4" of topsoil, seed with specified seed mix.			
Hole 5	3	3-4" diameter hole in surface of dam face		Remove vegetation, fill with compacted clay, cap with 4" of topsoil, seed with specified seed mix.			
Hole 6	4	4' diameter hole in surface of dam face		Remove vegetation, fill with compacted clay, cap with 4" of topsoil, seed with specified seed mix.			
Hole 7	4	4' x 3' slough in surface of dam face upslope from rip-rap		Remove dislodged soil and vegetation, fill with compacted clay, cap with 4" of topsoil, seed with specified seed mix.			
Hole 7a - related to adjacent slough	4	2' x 2' slough in surface of dam face upslope from rip-rap		Remove dislodged soil and vegetation, fill with compacted clay, cap with 4" of topsoil, seed with specified seed mix.			
Hole 8	4	minor slough in surface of dam face		Removed dislodged soil, remove vegetation, fill with compacted clay, cap with 4" of topsoil, seed with specified seed mix.

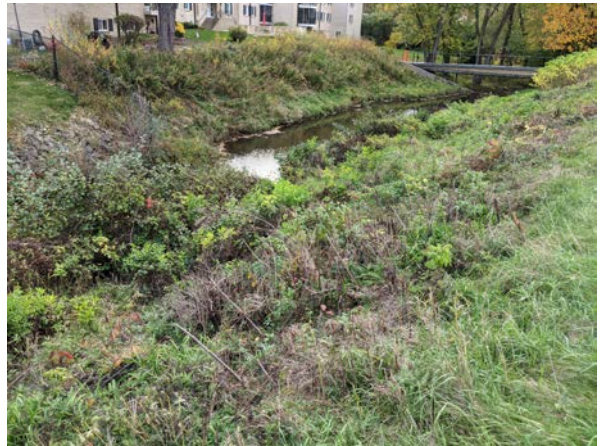
Wood plant material must be removed for turf growth.

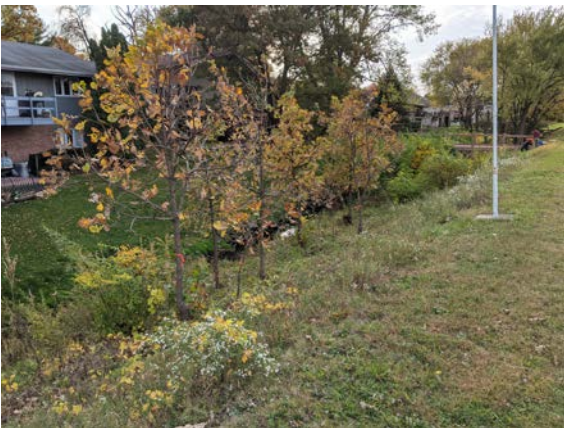
Tree removal on dam embankment.

4" diameter trees and larger must have the stumps removed and backfilled with compacted clay and topped with 4" of locally sourced topsoil. Trees smaller than 4" diameter should be cut level with the existing grade and treated with herbicide. Trees and branches must also be removed from the slopes. Once cleared of trees and woody
