2021 INTERIM INSPECTION MEMO Permit No. 17607 Dam ID No. IL 00545

SPRING LAKE DAM
WINNEBAGO, COUNTY, ILLINOIS

ARC DESIGN
RESOURCES INC.

October 20, 2021, Field Visit
November 9, 2021, Memo

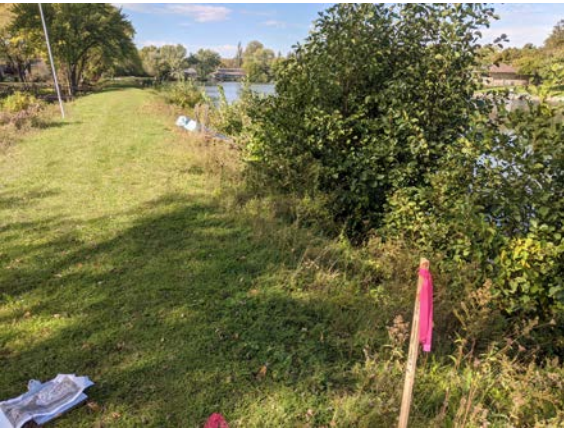
Woody plant material along bank must be removed.

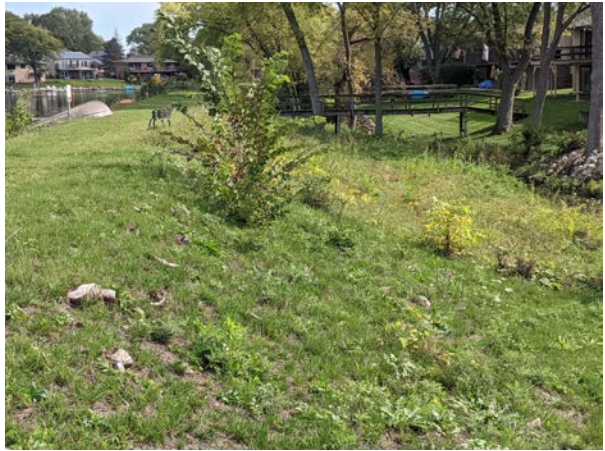
Some progress has been made on developing a turf surface for the dam. Woody plant material must be removed, stumps ground and backfilled with compacted soil.

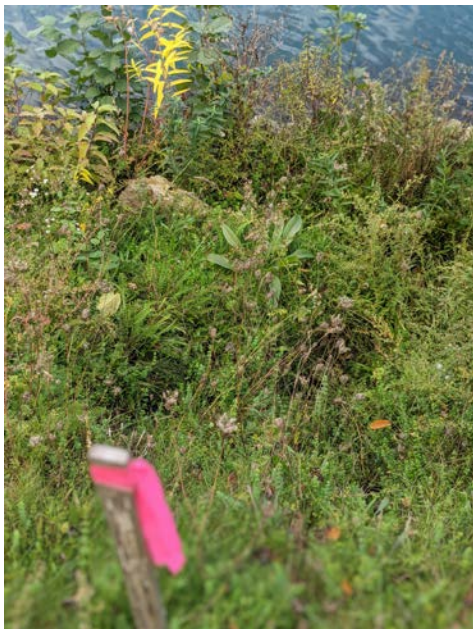
Sloughing and holes must be filled as specified with surface restoration.

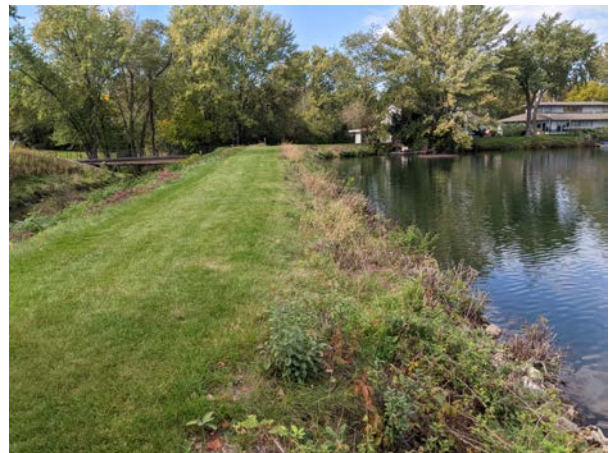
There is too much non-turf vegetation on the fore slope and backslope of the dam.
