**Re: Spring Lake Estates, Rockford, IL  
2025 Class II Dam Inspection Report**

# 2025 Class II Dam Inspection Report

Project 25-1597

October 2025

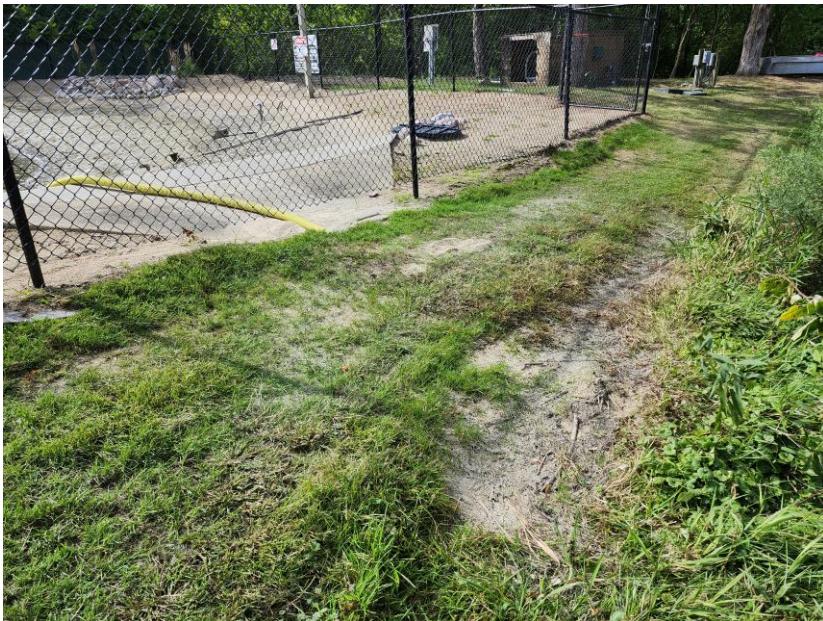
1. **LOCATION:** Swimming/Beach Area

**DESCRIPTION OF DEFICIENCY:** A small area of vegetation has been eroded away near the drainage spillway, causing exposed soil.

**MEASURE:** Remove all deposited silt from the eroded area, and re-spread topsoil and seeding. Stabilize with an erosion control blanket.

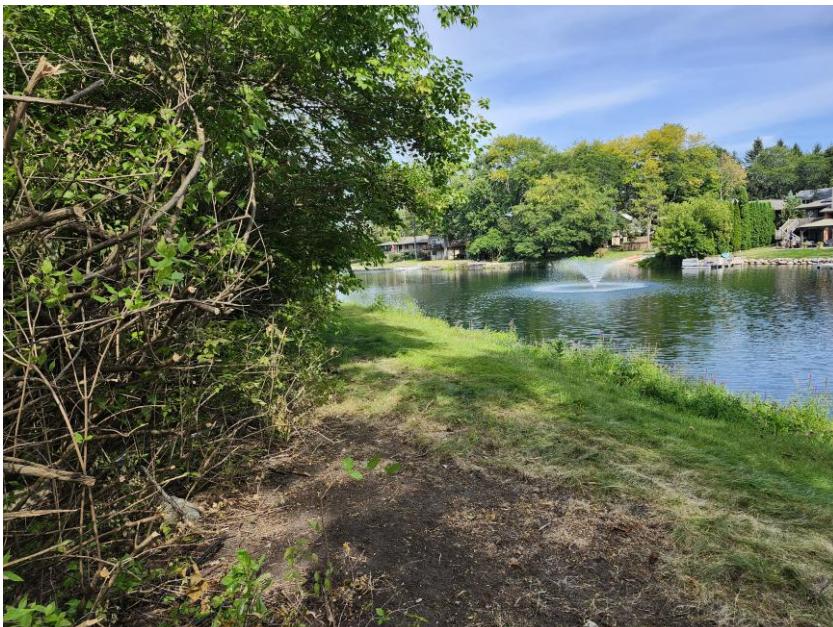
2. **LOCATION:** Lot 10, near the tree line

**DESCRIPTION OF DEFICIENCY:** Area of bare earth in the crest of the dam.

**MEASURE:** The Area should be monitored to ensure the problem does not spread to the slopes of the dam. If in spring, adjacent vegetation spreads to stabilize this area, no corrective action is needed. If vegetation does not spread in the spring, the area is to be seeded.

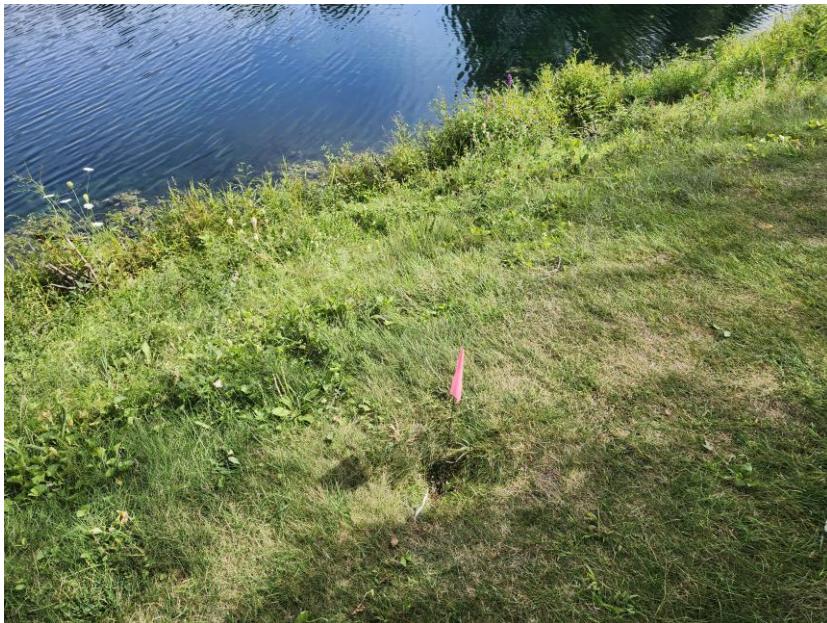
3. **LOCATION:** Lot 1, near the front slope of the dam.

**DESCRIPTION OF DEFICIENCY:** An Animal burrow hole was found in the dam.

**MEASURE:** The Dam should be continuously monitored for animal burrow holes, and if any are encountered, they should be filled with concrete slurry.

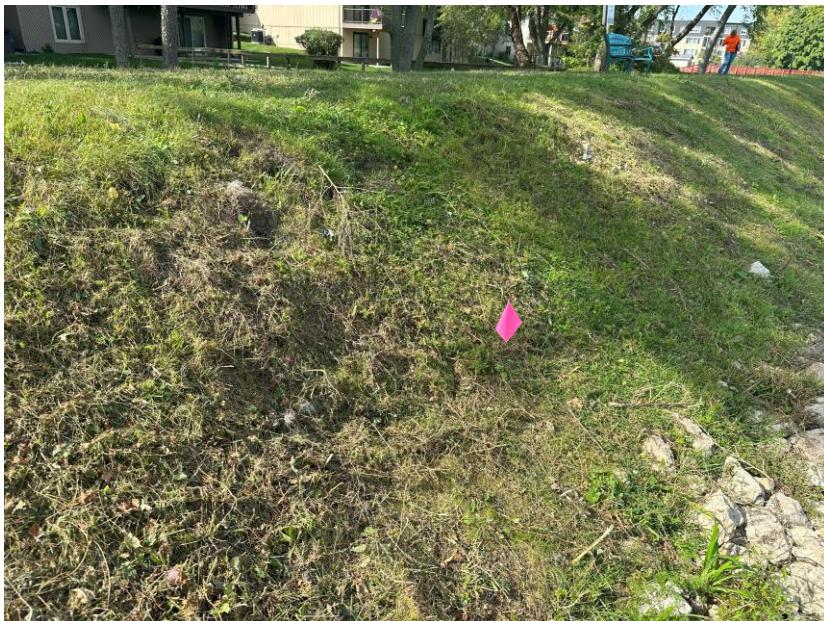
4. **LOCATION:** Lot 1, front slope of the dam.

Patchy areas of unhealthy grass and slope loss.

**MEASURE:** Continue observation, and if slope loss gets worse, stabilize with filter fabric and riprap.

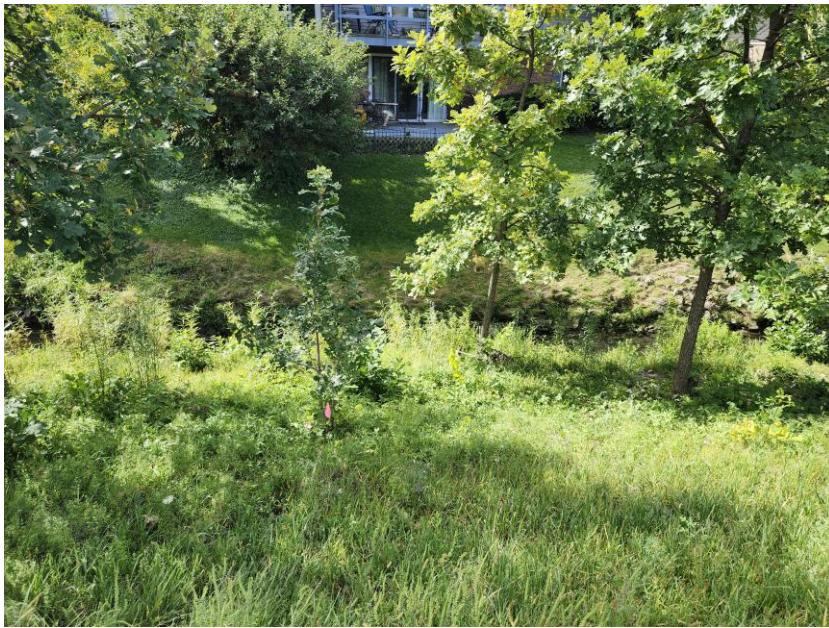
5. **LOCATION:** Lot 2 backslope

Several cases of large woody growth on/in the slope.

**MEASURE:** Woody growth should be cut within 3" of the ground to maintain dam alignment and stabilization.

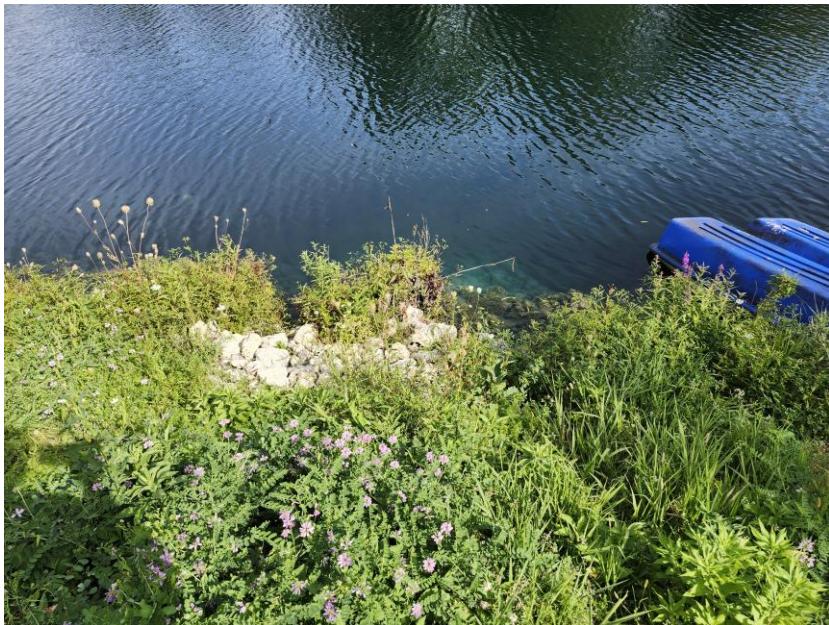
6. **LOCATION:** Lot 2, next to the water on the front slope.

Riprap appears to be in good condition but has become overgrown with vegetation.

**MEASURE:** Cut/trim vegetation growing within riprap and apply herbicide in accordance with accepted horticultural standards.

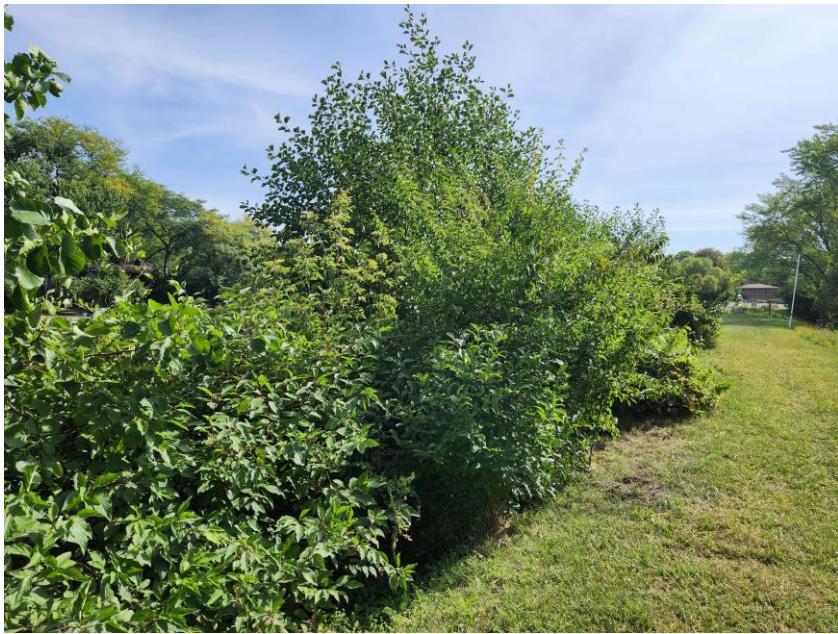
7. **LOCATION:** Lot 3, front slope of dam.

Large amount of woody growth and overgrown vegetation.

**MEASURE:** All weeds and woody growth must be removed flush with grade, and herbicide is to be applied in accordance with accepted horticultural practices.

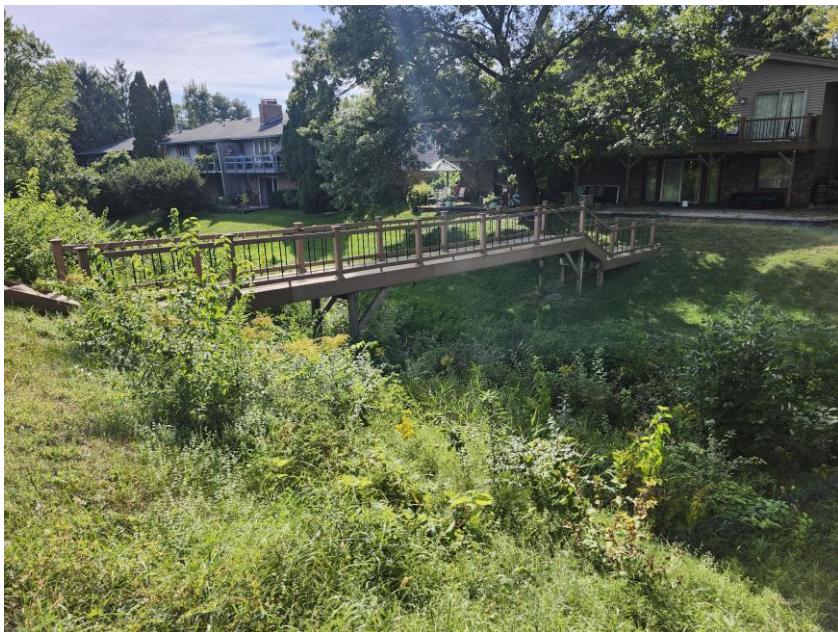
8. **LOCATION:** Lot 3, backslope near west property line.

Large amount of overgrown vegetation.

**MEASURE:** All weeds and woody growth must be removed flush with grade, and herbicide is to be applied in accordance with accepted horticultural practices.

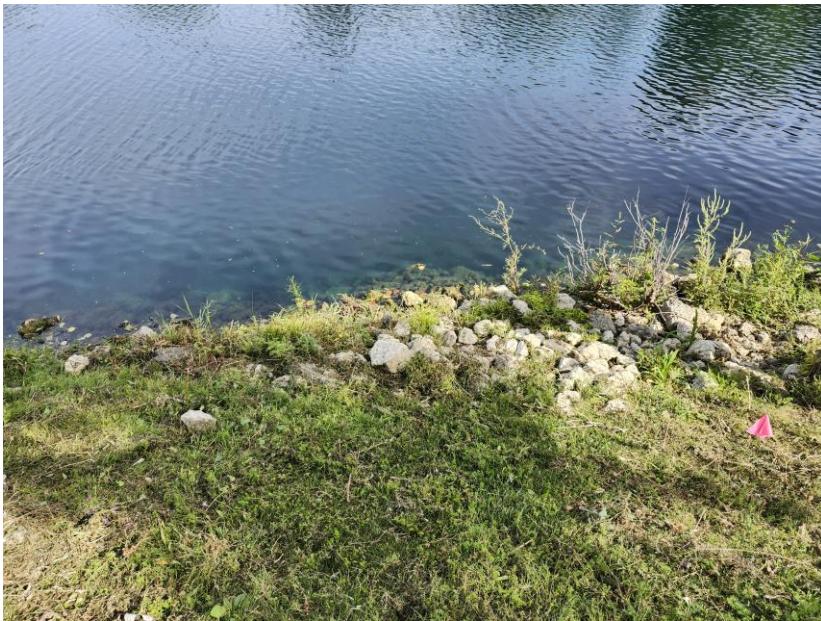
9. **LOCATION:** Lot 4, front slope of the dam

Riprap installed prior to inspection is mostly holding up well, but appears to be starting to erode on the east edge.

**MEASURE:** Continue to monitor to ensure erosion does not continue. If erosion continues, excavate the eroded area to a depth of 16", place filter fabric, and backfill with Riprap.

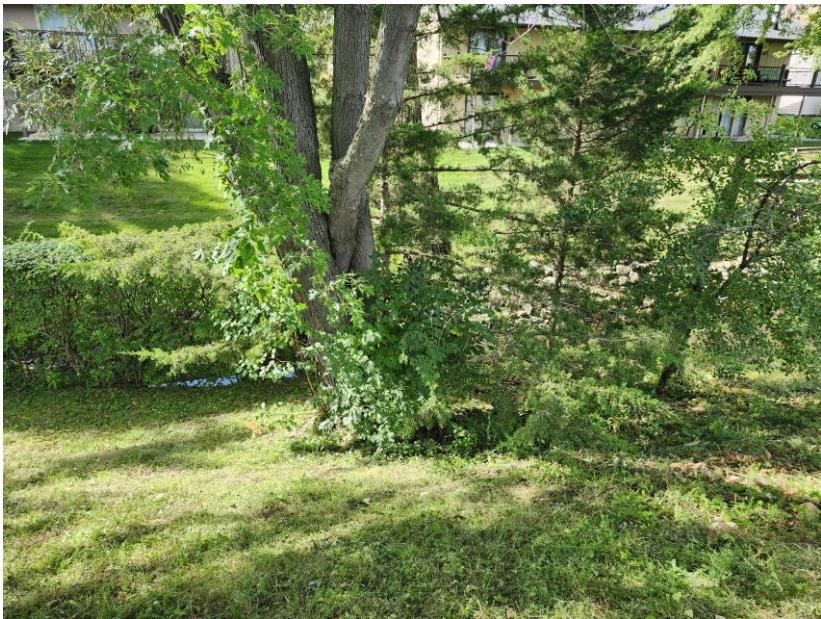
10. **LOCATION:** Lot 4, near the west property line on the backslope.

Large woody growth in the backslope of the dam.

**MEASURE:** Woody growth should be removed to maintain slope stabilization and alignment.

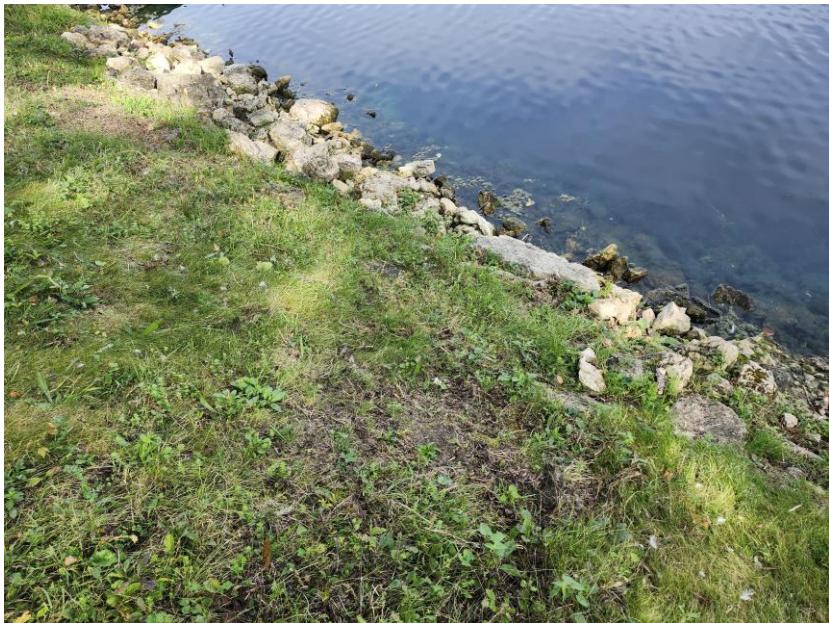
11. **LOCATION:** Lot 5, near East Property Line

**DESCRIPTION OF DEFICIENCY:** Area of bare earth.

**MEASURE:** Area to be seeded and the entire disturbed area to be stabilized with an erosion control blanket.

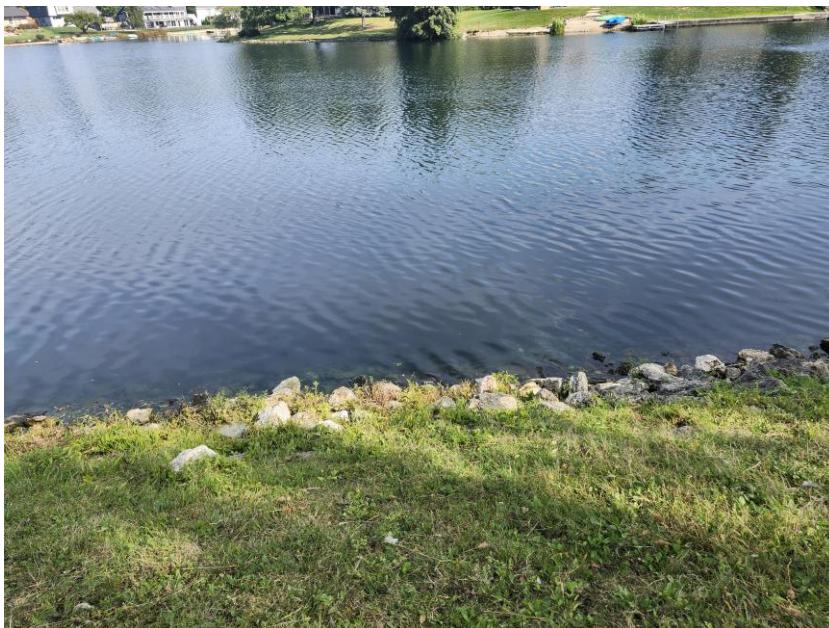
12. **LOCATION:** Shared property line of Lot 5 and Lot 6 on the front slope of the dam.

Riprap is in good condition, but is starting to get overgrown with vegetation.

**MEASURE:** Cut/trim vegetation growing within riprap and apply herbicide in accordance with accepted horticultural standards.

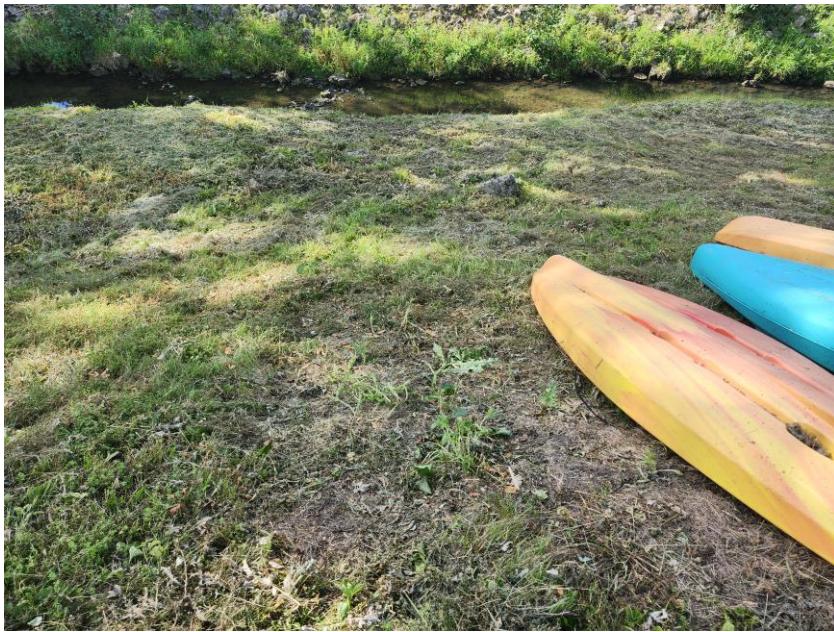
13. **LOCATION:** Lot 6, Dam backslope

Areas of bare earth on the dam slope from boats being stored.

**MEASURE:** Remove boats and continue to monitor. If vegetation does not extend by spring and there are still areas of bare earth, apply lawn seed and stabilize the disturbed area with an erosion control blanket.

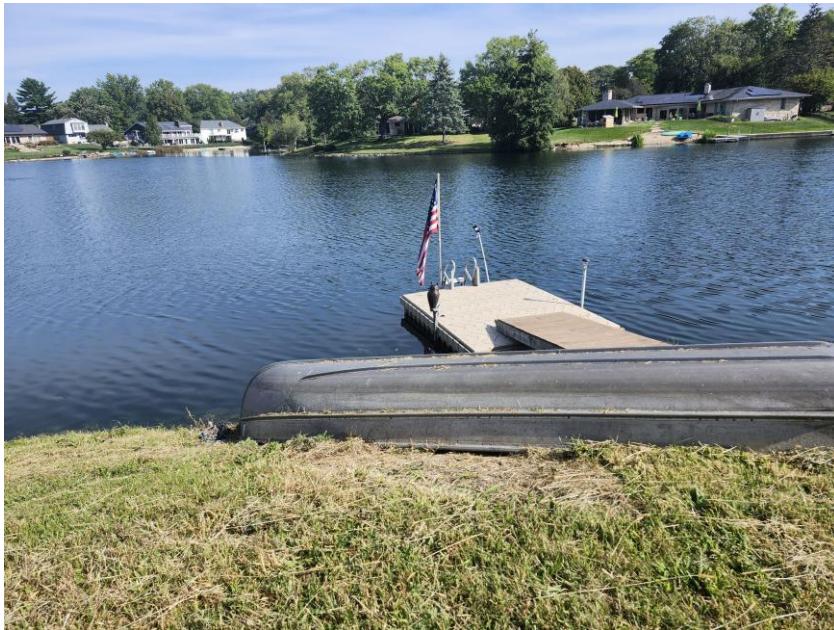
14. **LOCATION:** Lot 6, Dam front slope

Areas of bare earth on the dam slope from boats being stored on the grass.

Remove boats and continue to monitor. If vegetation does not extend by spring and there are still areas of bare earth, apply lawn seed and stabilize the disturbed area with an erosion control blanket.

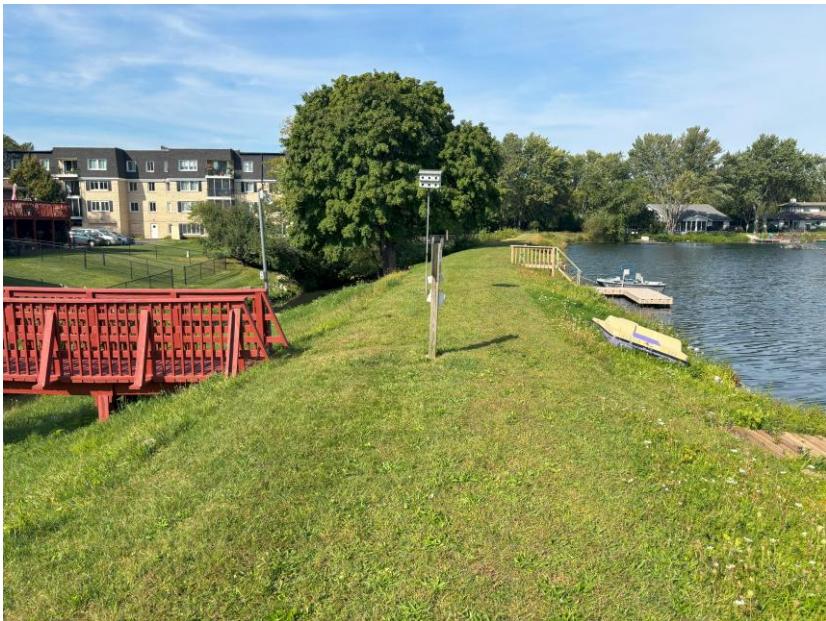
15. **LOCATION:** Lot 7, at the crest of dam

**DESCRIPTION OF DEFICIENCY:** No Deficiencies noted during inspection.

**MEASURE:** Ensure the boat does not cause vegetation loss in the slope of the dam. The area should continue to be mowed and monitored for erosion and animal burrow holes.

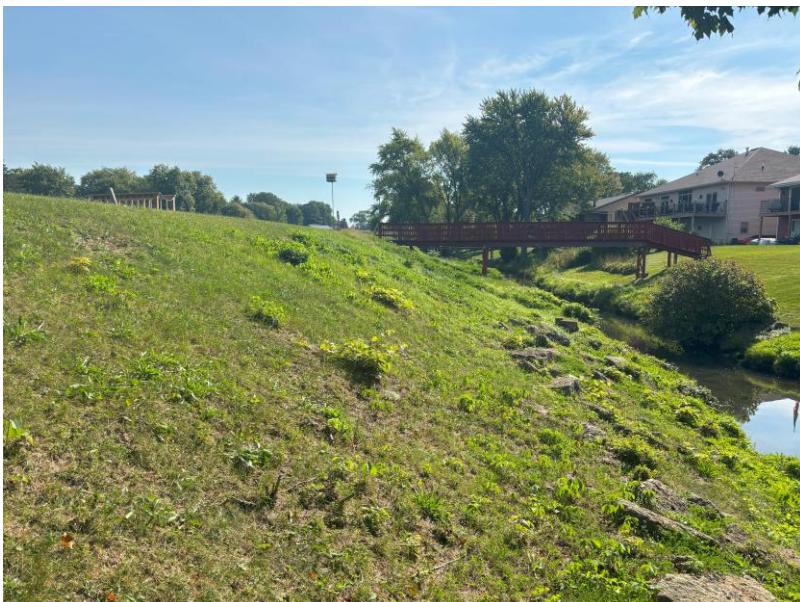
16. **LOCATION:** Backslope of the dam in Lot 8

**DESCRIPTION OF DEFICIENCY:** N/A Vegetation overgrowth has been removed, and it appears that rock has been added since the last inspection, and slope loss has not worsened.

**MEASURE:** The Area should continue to be monitored for erosion and slope loss.

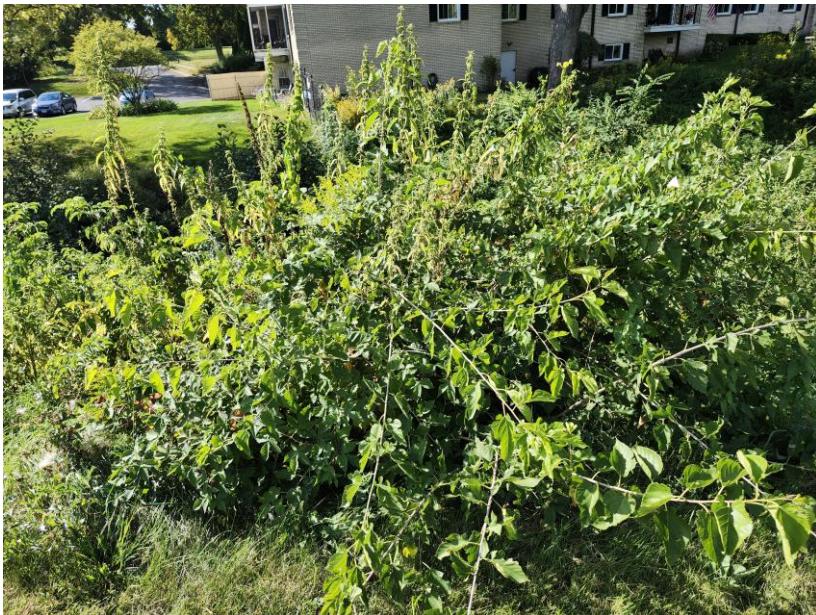
17. **LOCATION:** Lot 9, South slope of Dam

Large amounts of woody growth and overgrown vegetation on the backslope of the dam along the entire property line.

Woody growth should be cut within 3" of the ground, and herbicide should be used to treat woody growth in accordance with accepted horticultural practices.

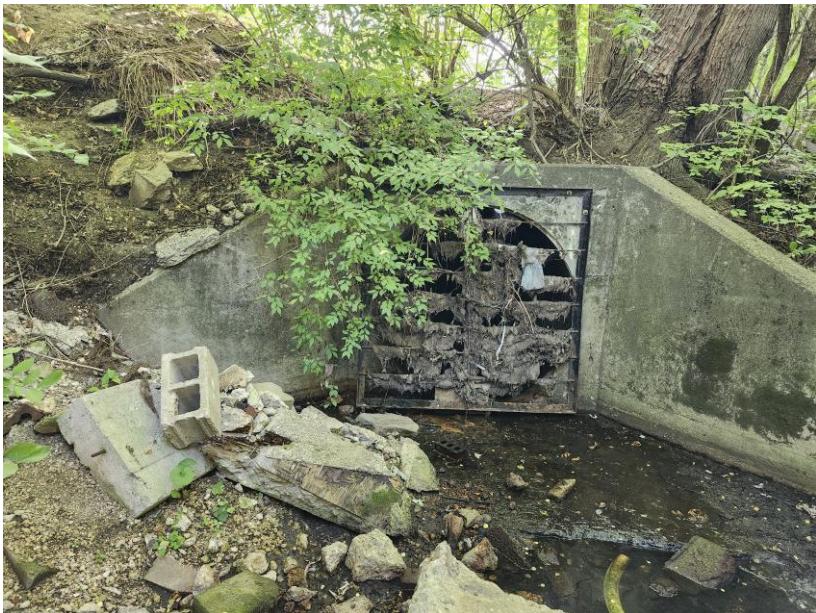
18. **LOCATION:** Primary Outlet Pipe Discharge at Southwest Corner of 3203 Montlake Drive.

Conditions were largely rated Good/No Evidence on the IDNR inspection form, with noted items of maintenance and observation being: minor erosion/sloughing and bare spots, scattered animal burrows, and significant woody growth on several privately owned segments of both the front and back embankment (See Attachment 3, Photos 3, 5, 7-8, 10, and 17). Minor cracking and spalling in the concrete outlet/valve structure was also observed ( See Attachment 3, Photo 22) along with the backup outlet valve being inoperable (Attachment 3, photo 23) , and debris was present at the discharge gate and in the plunge pool (Attachment 3, photos 18 and 19).

Minor debris caught on the metal grate at the outlet pipe discharge point.

4. Continue to monitor for animal burrow holes and fill any noticed holes with concrete slurry.
5. Monitor for any observed sloughing of the backslope.
6. Continue to remove any debris from outlet pipe grate.

**MEASURE:** All vegetation and debris caught in the grate should be removed and disposed of off-site.

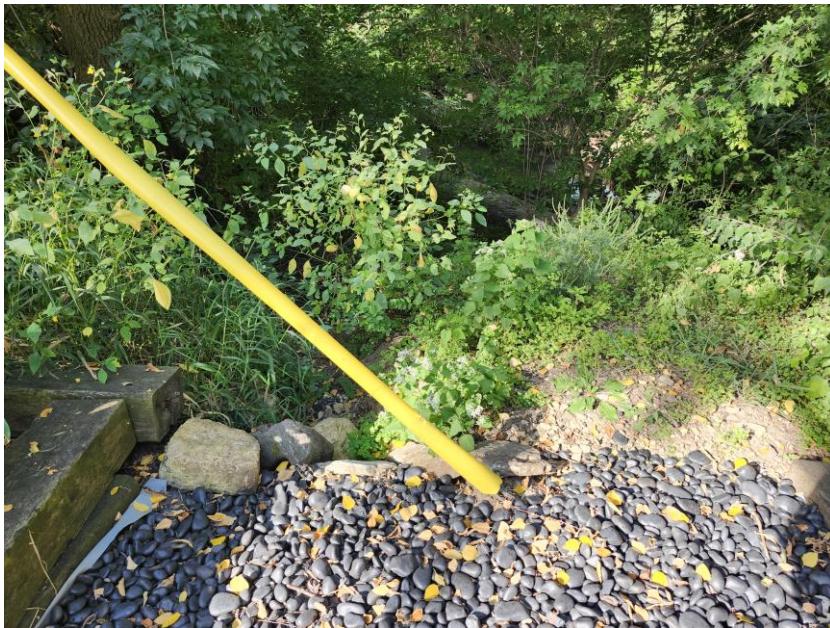
19. **LOCATION:** West of Driveway, 3203 Montlake Dr.

**DESCRIPTION OF DEFICIENCY:** The Earth behind the landscape rock has been eroded due to overland storm discharge.

**MEASURE:** Eroded area should be excavated to a depth of 16 inches, and filter fabric and Rip-Rap Gradation RR-4 or CA-1 should be installed.

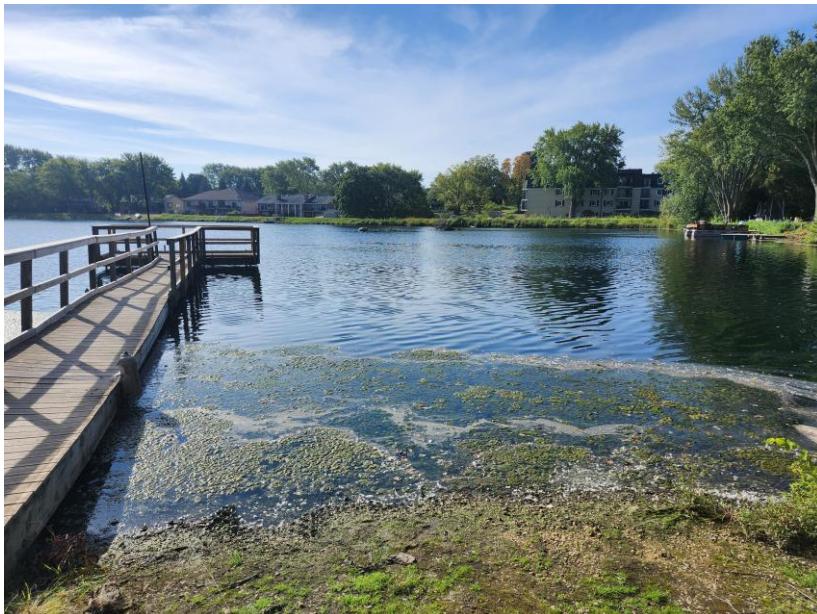
20. **LOCATION:** Emergency Spillway Location near the fishing dock on Montlake Drive

**DESCRIPTION OF DEFICIENCY:** No deficiencies noted during inspection.

**MEASURE:** The Area should be continuously monitored, particularly after heavy rainfall, to ensure the area does not start to erode.

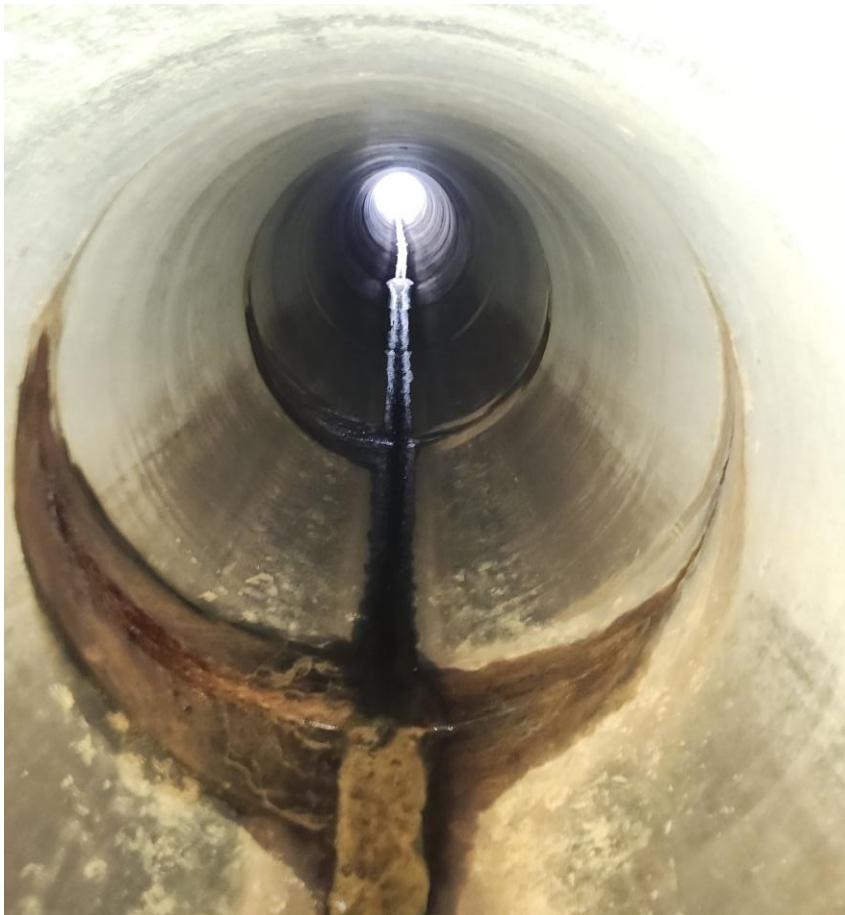
21. **LOCATION:** Inside principal spillway pipe looking upstream.

Seepage noted in the bottom of the pipe at some joints.

**MEASURE:** Monitor to be sure the condition does not worsen and seepage and material loss do not occur at the top of the pipe.

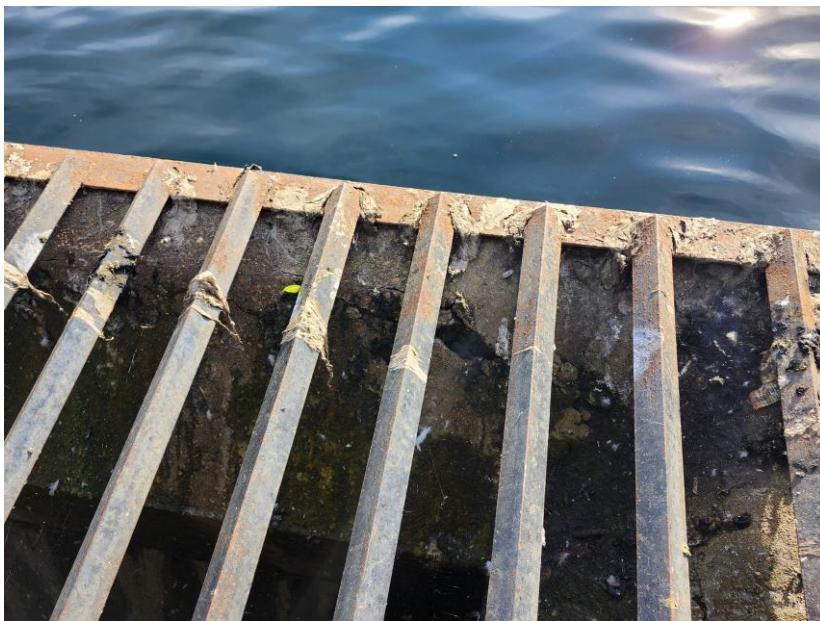
22. **LOCATION:** Top of Principal Spillway and Valve Structure

Cracking and spalling in concrete near the top of the structure.

7. Continue to remove any vegetative, animal, or other debris from outlet structure.
8. Consider patching areas of spalling concrete in outlet structure, or continue to monitor to ensure condition does not worsen.

**MEASURE:** Also, the structure should continue to be monitored for animal, vegetation, and trash buildup and removed when necessary.

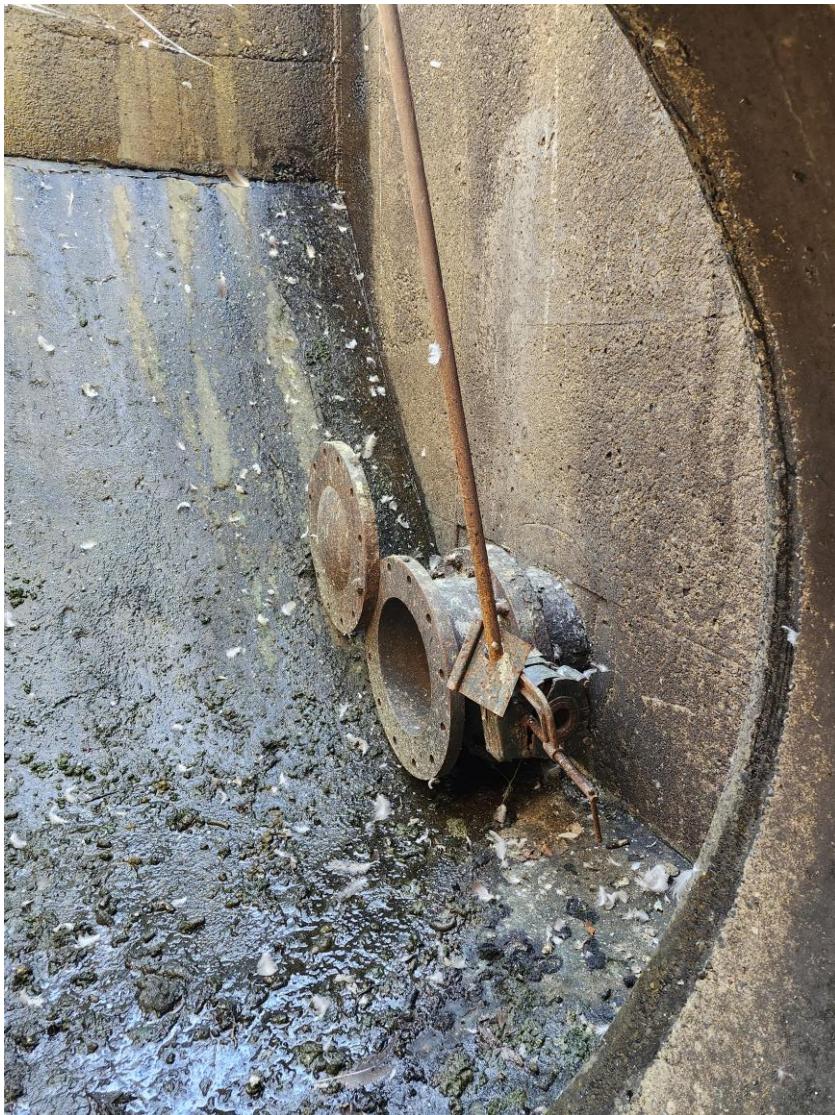
23. **LOCATION:** Inside Principal Spillway and Valve Structure

**DESCRIPTION OF DEFICIENCY:** The Backup valve is broken and inoperable.

9. Clean-up debris from plunge pool.
10. Repair or replace existing backup valve that is inoperable.

**MEASURE:** The Valve should be replaced or repaired to working condition.
