## **2020 INTERIM INSPECTION MEMO Permit No. 17607 Dam ID No. IL 00545**

**SPRING LAKE DAM  
WINNEBAGO, COUNTY, ILLINOIS**

October 21, 2020

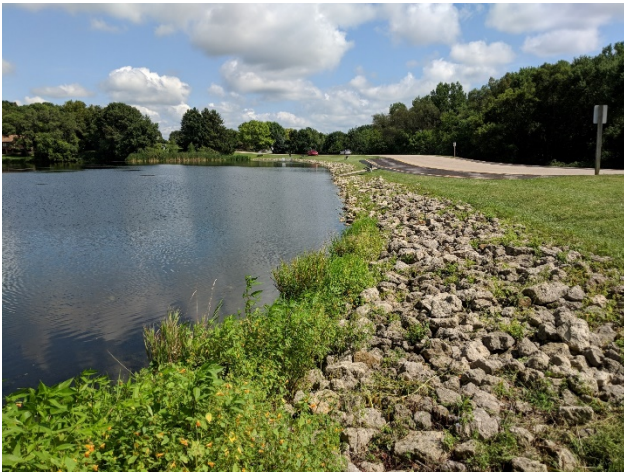
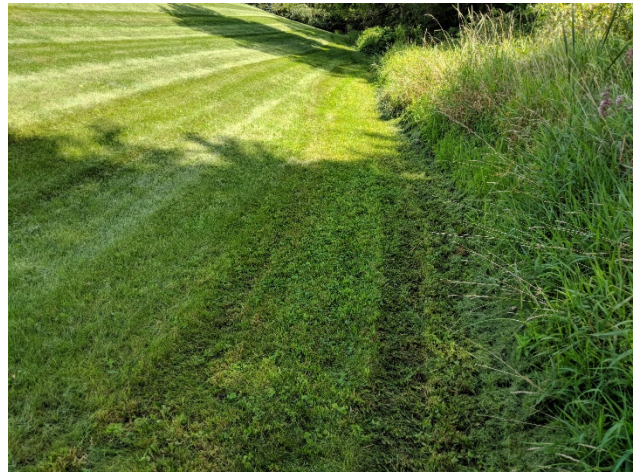
These two photos represent the goal for a well-maintained turf surface on an earthen dam. The dam at Spring Lake Estates could look like this with proper tree and shrub removal, topsoil dressing, and quality seed mix, fertilizer, and watering.

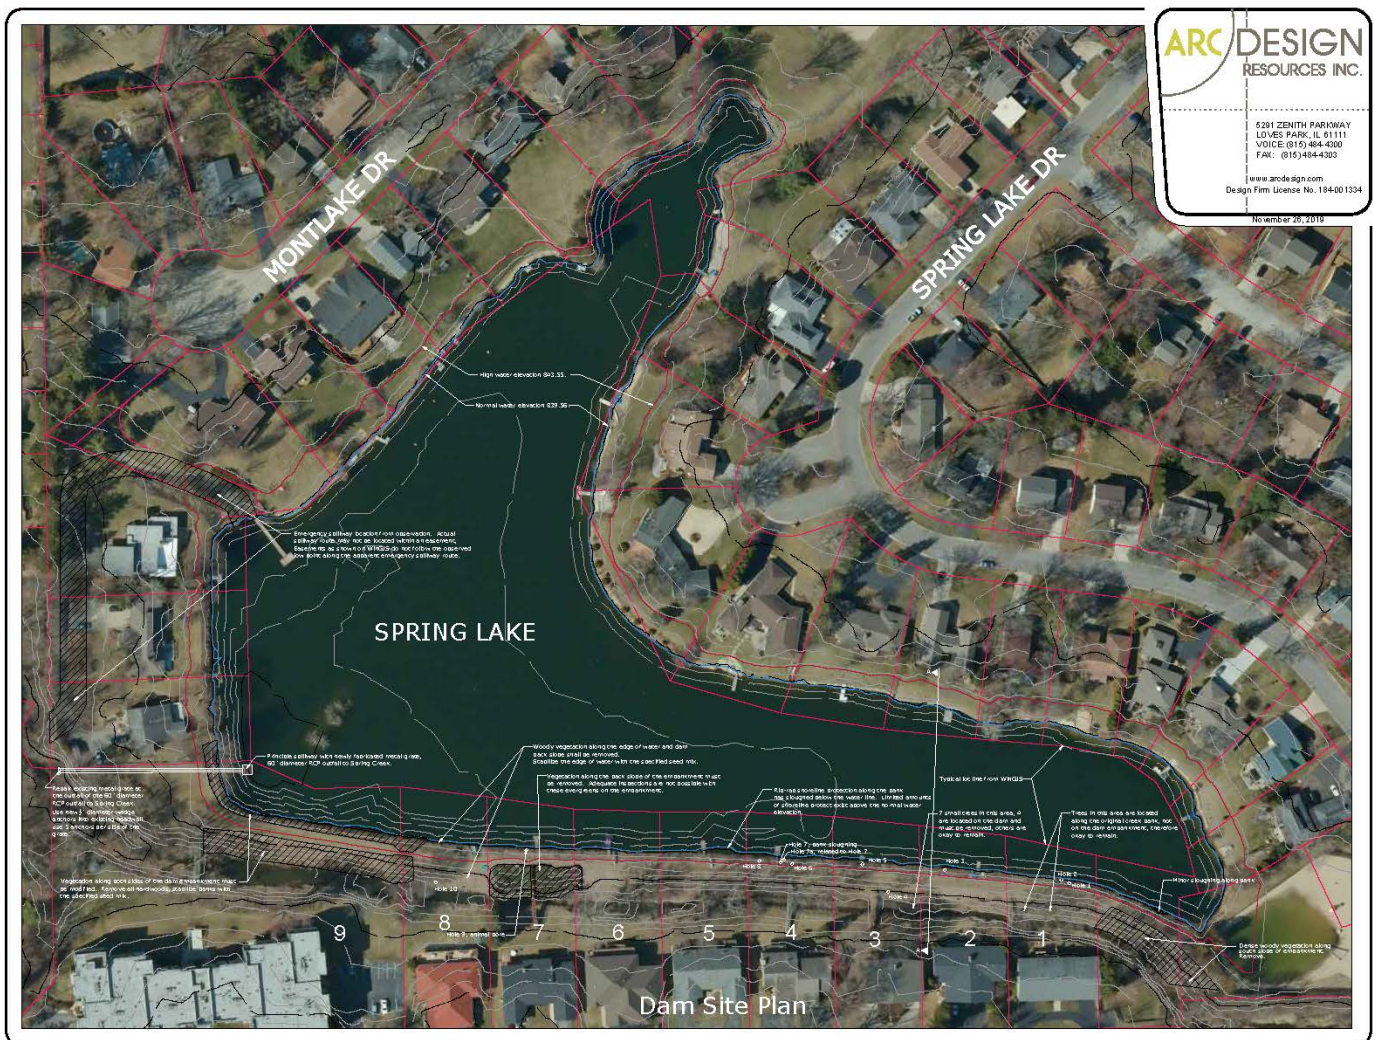
Lake photo showing lot numbers as referenced in this memo.
