2021 INTERIM INSPECTION MEMO Permit No. 17607 Dam ID No. IL 00545

SPRING LAKE DAM
WINNEBAGO, COUNTY, ILLINOIS

ARC DESIGN
RESOURCES INC.

October 20, 2021, Field Visit
November 9, 2021, Memo

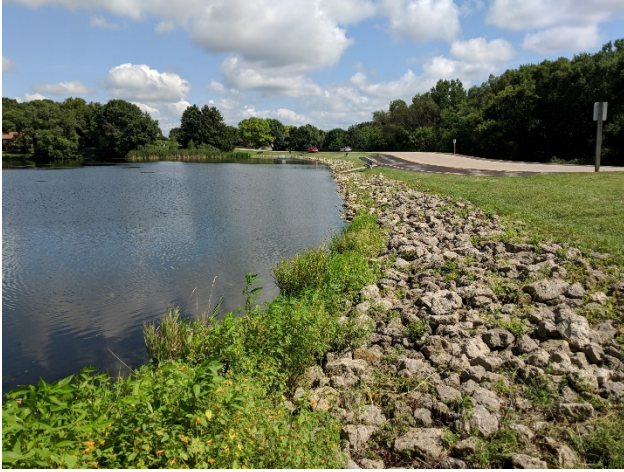
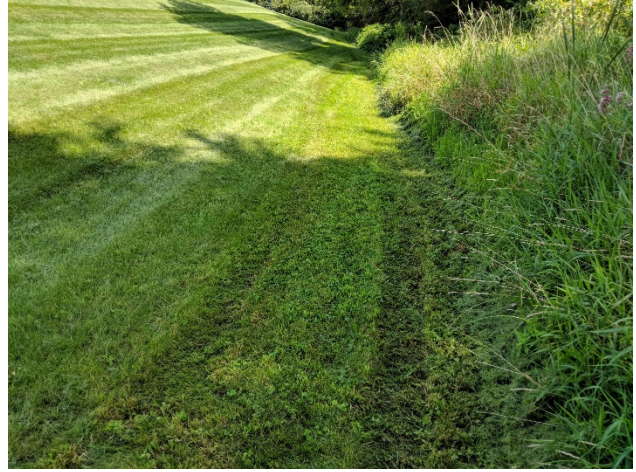
These two photos represent the goal for a well-maintained turf surface on an earthen dam. The dam at Spring Lake Estates could look like this with proper tree and shrub removal, topsoil dressing, and quality seed mix, fertilizer, and watering.

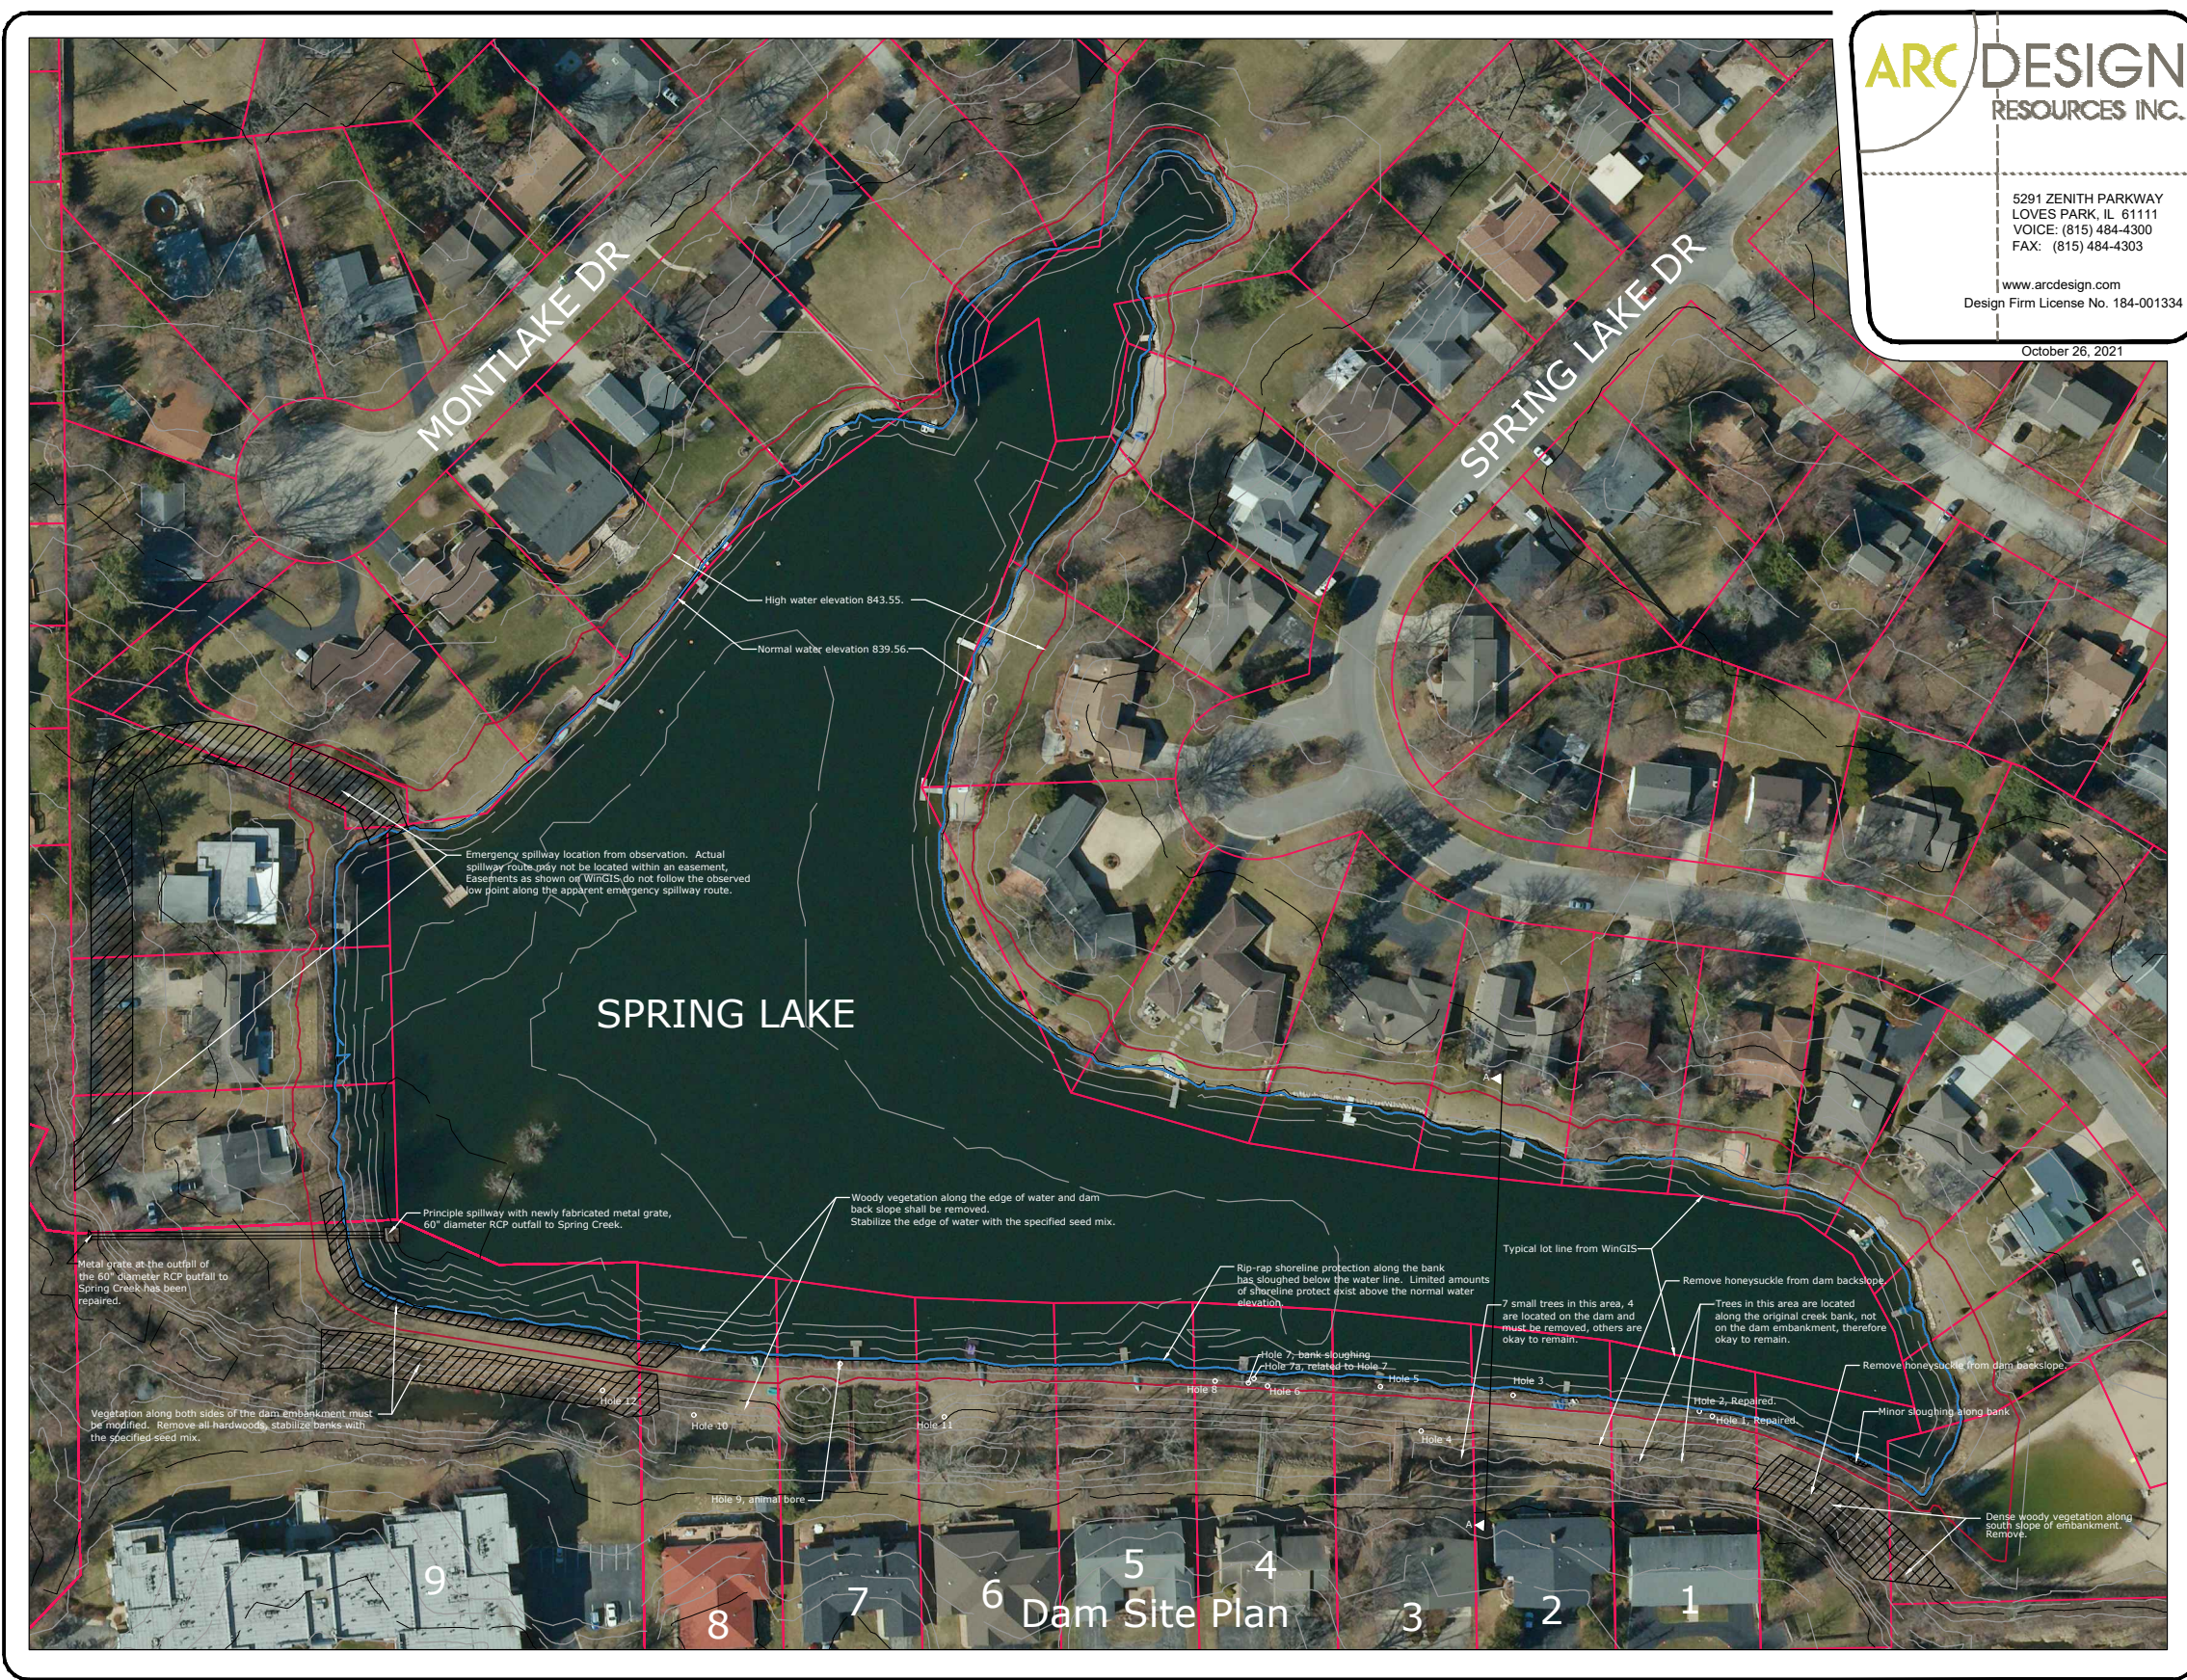
A lake photo showing lot numbers and required maintenance items is included as an 11 x 17 exhibit.

Item Description on Dam Site Plan	Lot No.	Detailed Description		Repair Recommendation		
Minor sloughing along bank, woody plant material is growing	1	Soil embankment slope has become steeper due to lack of stabilizing rip-rap. Woody plant material along bank.		When lake level is down 2 feet, recompact weakened soil plane, add compacted clay, line with geotextile fabric, pull up sloughed rip rap along repaired slope to two feet above normal water level. Remove plants from edge of water.		
Hole 1	1	6" diameter hole in surface of dam face		Repairs have been completed.		
Hole 2	1	6" diameter hole in surface of dam face at water level		Repairs have been completed.		
Hole 3	2	3-4" diameter hole in surface of dam face		Remove vegetation, fill with compacted clay, cap with 4" of topsoil, seed with specified seed mix.		
7 small trees in this area, four on the back slope of the dam must be removed	2-3	3 of the 7 trees in this area must be removed because they are on the back slope of the dam. The remaining trees are in the creek channel.		Remove tree, cut stump off level with ground surface, treat stump with herbicide. Remove vegetation along the edge of water. Remove honeysuckle from backslope.

Hole 8	4	minor slough in surface of dam face, backslope surface repairs.		Removed dislodged soil, remove vegetation, fill with compacted clay, cap with 4" of topsoil, seed with specified seed mix. Remove vegetation along the edge of water. Repair backslope at toe of dam.		
Remove two trees from the backslope of the dam embankment, trees are flagged.	4	Remove trees		Grind stumps, fill with compacted clay, cap with 4" of topsoil, seed with specified seed mix.		
Woody vegetation along water's edge	5-6	Remove woody stemmed plants		Grind stumps, fill with compacted clay, cap with 4" of topsoil, seed with specified seed mix.		
Hole 11 - dam back slope also has grading irregularities in this area.	6	An animal bore hole exists, the area surrounding the hole is poorly graded.		Fill hole with compacted clay, regrade the area to match the adjacent grades, compact and restore the surface with the specified seed mix.

Vegetation along the back slope of the embankment must be removed	7	Evergreen plants have been removed		Replace disturbed soil with compacted clay, cover with 4" of topsoil, apply specified seed mix.		
Hole 9, animal bore	7	2" diameter hole in surface of dam face		Remove vegetation, fill with compacted clay, cap with 4" of topsoil, seed with specified seed mix.		
Hole 10	8	3-4" diameter hole in back slope surface of dam face		Repair has been completed. Remove woody plants from the edge of water.		
Large maple tree, honey suckel shrubs	8-9	Trim maple tree to let sun light on dam bank. Remove all honey suckel shrubs.		Trim tree, (trimming complete) remove woody plant material and roots. Replace disturbed soil with compacted clay, cover with 4" of topsoil, apply specified seed mix.		
Vegetation along both sides of the dam embankment must be modified	9	Excessive plant growth on dam embankment and along water's edge is not acceptable.		Remove all woody plant material and roots. Replace disturbed soil with compacted clay, cover with 4" of topsoil, apply specified seed mix.
